RELIABILITY PROBLEMS WITH LARGE POWER TRANSFORMERS AND SHUNT REACTORS. TYPICAL FAILURE MODES AND FAILURE CAUSES

V. Sokolov, S. Tsurpal
Ukraine,

A. Drobyshevski
Russia

Abstract

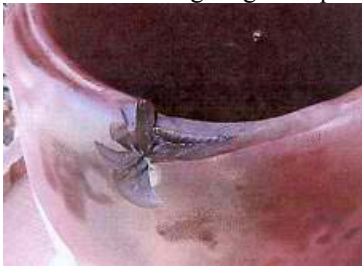
Several failure cases occurred due to poor performance of 500 kV bushing shield, namely hidden defect of the metallic mesh with presence of sharp ages. (Fig.5). That resulted in PD activity under effect of switching surge and power arc to the turret

Figure 5
Hidden defect of metallic mesh

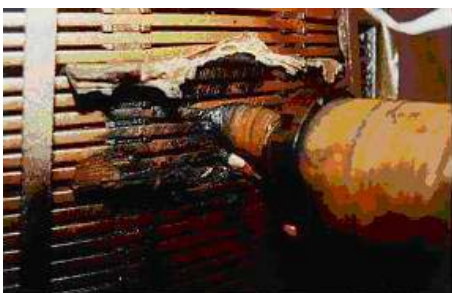
Breakdown of oil duct due to free water. Poor or deteriorated top sealing of draw lead bushings as well as poor sealing of explosion vent remained to be repeated worldwide cause allowing penetration of rain water into transformer and resulting in of a sudden breakdown oil duct between coils of HV or RW windings .

Figure 6
Short-circuit between coils due to introducing free water through poor bushing top sealing

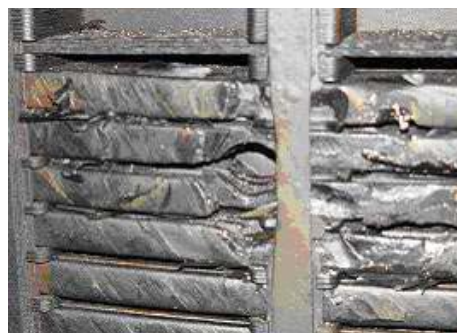
General “aging” problem is accumulation of conductive and polar particles in oil and depositing them on the surface. Insulation surface contamination has been observed in the form of the adsorption of oil aging products with cellulose or deposit of conducting particles and insoluble aging products in areas of high electrical stresses. Contamination can cause a distortion of electrical field and a reduction in the electrical strength resulting in breakdown between coils and flashing over HV winding under effect of switching surge and lighting impulses.

Figure 8
Failure of 330 kV winding contaminated with conductive oil by-products under lighting surge

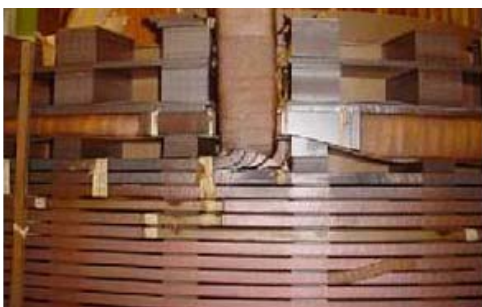
Figure 9

Failure of 700 MVA generator transformer after 25 years due to overheating the two top coils of LV winding (CTC wire) resulting in short circuit between parallels and then between turns

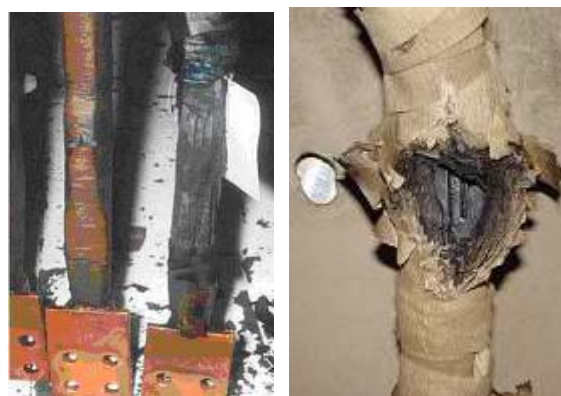
Figure 10

Overheating and burning out leads insulation in 700 MVA GSU transformer

Left: Overheating and short-circuit between parallels of LV lead exit

Right: burning out internal layers of HV lead

Design review and relevant calculations have shown that performance leads by winding wire without increasing cross-section can be a subject of special concern especially when a thick lead insulation is used. One should emphasize that design review is likely the only effective tool to identify the problem. Considering a limited amount of overheated insulation DGA and Furans analysis show clear symptoms of fault only on the stage when short-circuit between strands and insulating burning occur.

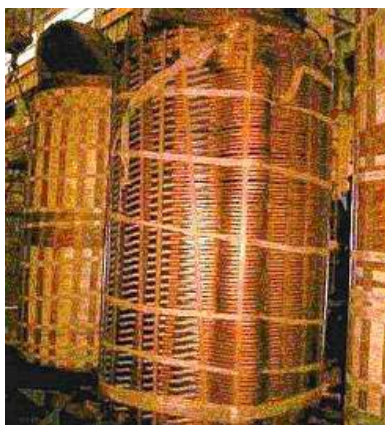
Figure 11

For example step-down 80/33 kV transformer failed due to dramatic distortion of LV winding (Fig 11). It was found that transformer, which was manufactured in 1974 has very low radial stability (Tabl. 1). Taking into account a long service life and inevitable loosing the winding claming half-shifted for of deformation was expected

Radial buckling of LV winding after 3 phases short-circuit on LV side
Half-shifted form of of loss stability revealed.

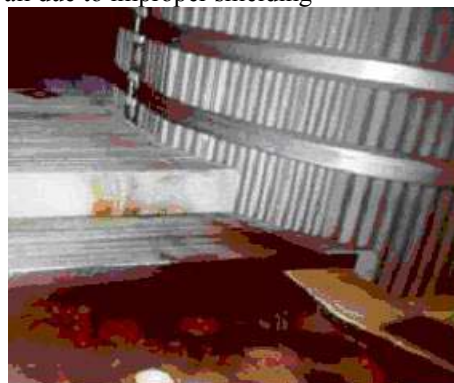
Figure 12

In the first group typical defects are overheating of core frame due to absence or improper disposition of magnetic shields on the frame (Fig. 12), overheating of pressing of the pressure bolt that situated just under the core yoke, overheating a part of the tank wall due to improper shielding

Overheating the bottom frame and adjusted insulation in 730 MVA generator transformer due to improper disposition of magnetic shields

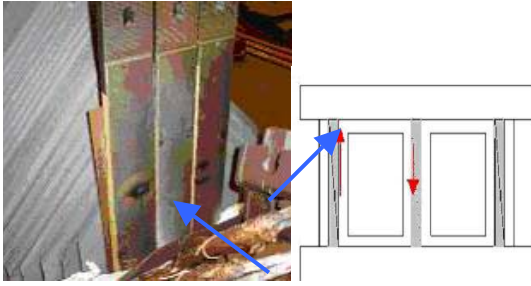
Loose contact in circulating loop provided with construction (Fig. 13)

Figure 13
Overheating in the loosed place between members forming loop for circulating current in 700 MVA transformer

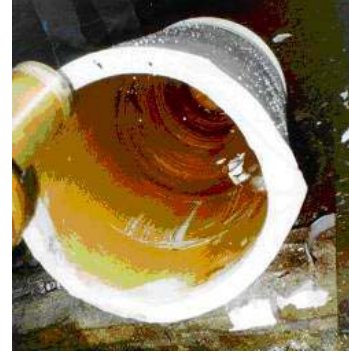
Discharges across the inner part of the transformer end porcelain are outcome of a typical aging-mode phenomena in the bushing. The failure process is initiated and developing within the oil channel between the core and lower porcelain. Another option is formation conductive residue on the external porcelain surface by means of attracting conductive by-products from transformer oil.

Figure 14
Internal staining with aged oil by-products containing metal colloids

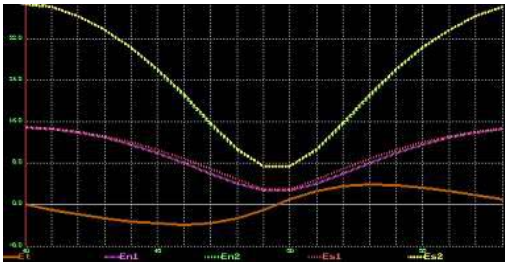
Figure 12

Electrical field of the bushing porcelain surface
The electrical field intensity across the porcelain surface facing the tank wall may be as much as 6 times greater than that on the opposite side
