# **Transformer is gassing-What to do**

V.V. Sokolov

Z. Berler,

## **Abstract**

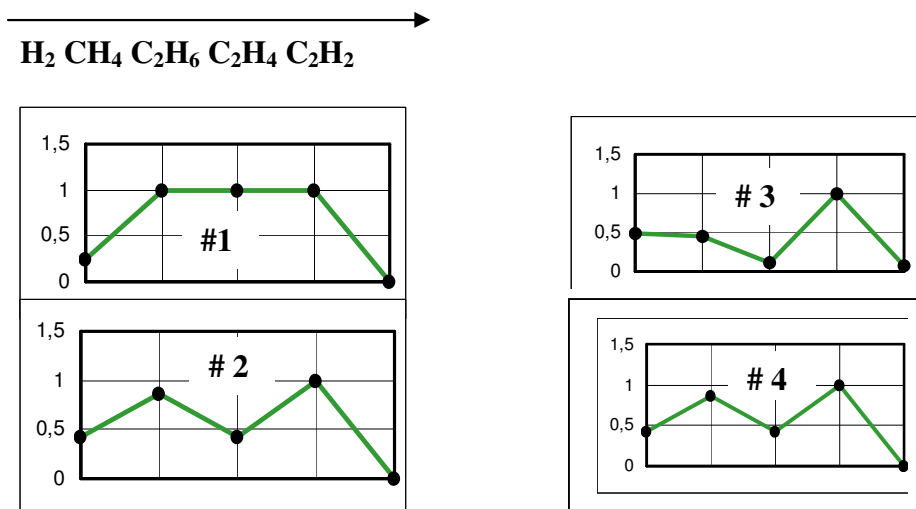
Figure 3  
Gas patterns in the cases of burned motor winding in the pump

Burned motor winding in the pump is a typical external-mode source of a high gas generation in transformer oil. Some examples that may give an idea about gas spectrum are shown in the Table 5. One can see that it is not easy to identify the failure mode using traditional gas ratio. Unusual patterns of gases sometimes may suggest the type of problems. There has been only one registered case when acetylene was generated due to the failed motor presuming that sparking between phases was a physical source of gas generation. However the ethylene and methane were the key gases in the case #1,2,3

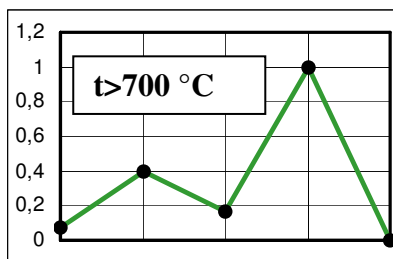
Figure 4

An auxiliary transformer of a 1000 MW nuclear power plant unit 63 MVA 24/6.3/6.3 kV, 1515.5/2887/2887 A, was in the service since 1984. In December 1997 DGA analysis revealed a clear symptoms of thermal decomposition (6). Localized oil overheating with local temperature over 700 °C was suggested. Rate of gas generation was estimated as 239 ppm/day or 590 ml/day. ZTZ-Service advised to check the influence of load on gas generation. After load decreasing gas generation practically stopped. It was suggested that the problem is associated with bad contact in the current flow circuit. The winding resistance test was advised to identify the problem. The unit was left in operation for another two weeks until the planned de-energizing. The test of LV2 winding showed increasing contact resistance in phase” b” by 212 μΩ The operating current of 1440 A could produce localized “heater” of 440 W. Inspection revealed severe overheating of LV2 lead connection.

Winding	Resistance, μΩ			Difference between phases
	a-b	b-c	c-a	
LV1	2582	2626	2610	1.7 %
LV2	<b>2992</b>	<b>2840</b>	2780	<b>7.6 % or 212 μΩ</b>

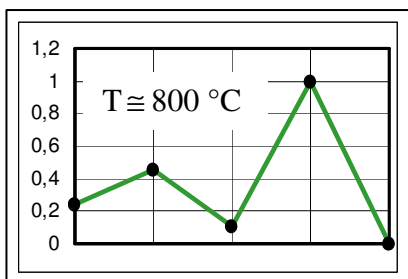
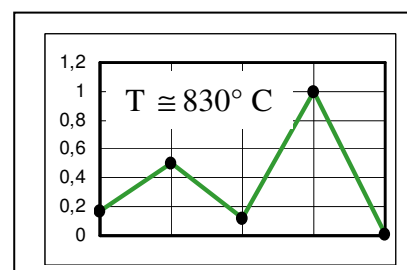
Figure 5  
Gas patterns prior and after Heat Run Test

250 MVA, 330/150 kV autotransformer after 20 years of service has shown symptoms of oil overheating. Localized oil overheating with estimated temperature about 800C was suggested (Figure 5, Table 7). Based on the test program, that incorporated checking the condition of pumps, leads and OLTC contacts, and possible loops associated with the main magnetic flux, the problem associated with stray magnetic flux was suggested. The Heat Run Test was advised to determine the serviceability of the unit. Load was increased from 60 % up to 100 % for 8 hours. Increasing of load results (Table 7) in rise of gas generation up to 4100 ml/hour and appearance of acetylene. The unit was left in operation with limited load.

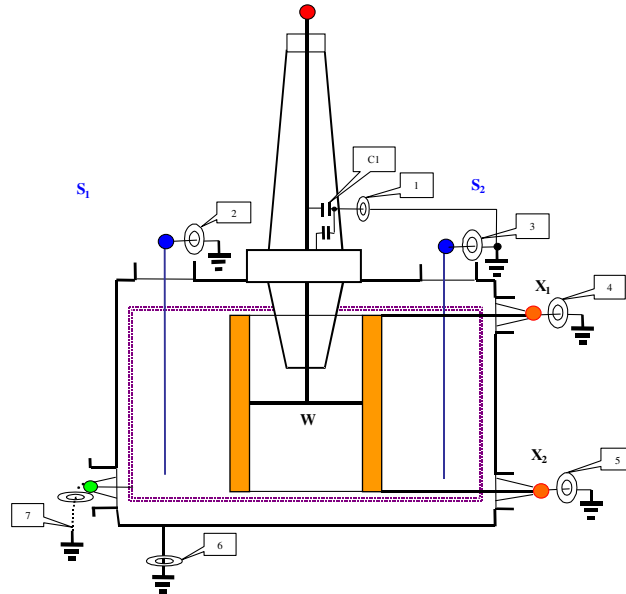
Figure 6  
General View of the 750 kV Shunt Reactor and Sensors Location

The Shunt Reactor 110 MVAR,  $750/\sqrt{3}$  exhibited both symptoms of arcing and localized overheating with estimated temperature about 800 °C. Continuing of its operation was critical, and decision was taken to verify whether the winding insulation involved. PD electrical test was performed using PD Analyzer and 6 sensors connected to the Bushing's Tap, electrostatic shields and grounding leads (see Figure 6).

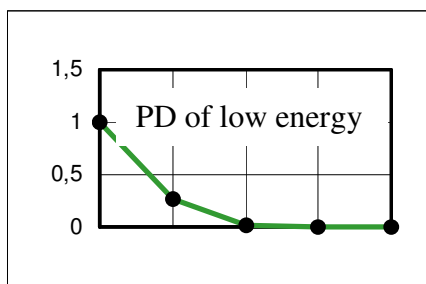
Figure 8  
Gas Pattern in 750/500 kV Unit

Rate of Hydrogen generation constituted 300-720 ml per day that corresponds to 6-14.4 kJ of dissipated energy or about 70-170 mW of average PD energy

PD-electrical tests were suggested to identify whether a source of gas generation relates to PD activity in a critical insulation zone. Results are presented in the Table 12. A source of PD with maximum pulse magnitude about 1600 pC and average power about 4 mW was suggested near the 750 kV line terminal. However this power was not sufficient to cause oil decomposition and gas generation. Results of combined electrical and acoustic PD tests suggested that more likely source of gas generation could be associated with floating potential and located in the zone of magnetic shields disposition on the tank wall. The autotransformer was left in service until repair that appointed for summer 2001.

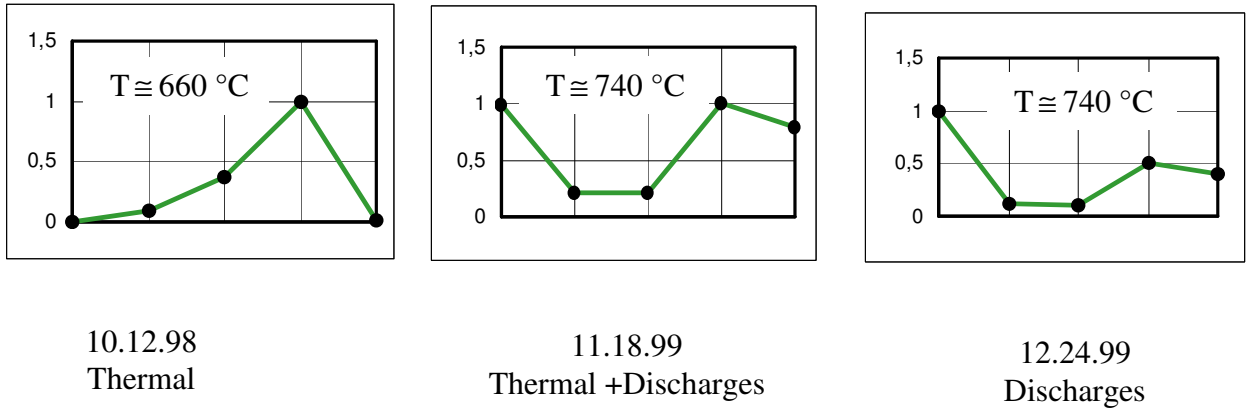
Figure 9  
Gas Patterns in the 167 MVA Autotransformer

167 MVA,  $500/\sqrt{3}$ ,  $230/\sqrt{3}$ , 15,8 kV, GSU autotransformer after 28 years of service exhibited gas evolution. Continuing of the unit operation was very critical and only short time outage was accepted to identify and fix the problem. DGA analysis showed that the unit exhibited symptoms of thermal fault until October 1999 and clear symptom of intensive PD activity since the middle of October. Reduction of load for a day on request of the ZTZ-Service resulted in clear mitigation of gas generation. Thus, it was found that source of gas generation is associated with load. Based on the design review two problems in the autotransformer were suggested: occurrence of a closed loop linked by stray flux (a source of arcing) and a thermal fault likely due to contacts overheating. Internal inspection was advised with the goal to fix the problem.

A closed loop between the core frame and the tank was found as a possible source of arcing. Moreover severe overheating of the selector contacts that practically operated only on the odd tap position was revealed. A terminal solution was advised to continue operation of the unit: to limit the current in the closed loop by means of resistance introduction and changing position of the selector. Gas generation was stopped (see the Table 13) and in summer 2000 the problem was completely fixed during in-field repair of the autotransformer.

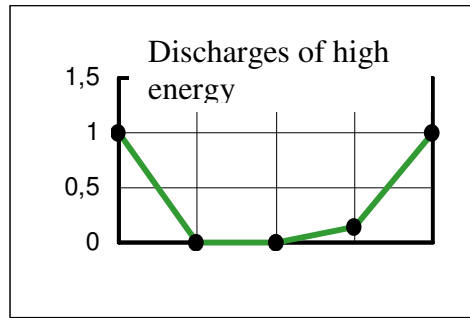
Figure 10  
Gas Patterns in the 400 MVA transformer

Subsequent oil analysis showed the decreasing of gas concentrations. Leakage Impedance Test was advised to verify mechanical state of the winding. Test results are given in the Table 15.

In such a transformer design practically only buckling of the inner HV2 winding could be expected. Relative change of the leakage impedance on the phase A increased by 2.63 % relative to the nameplate (average) data and by 2.37 % relative to the per phase reference test. However design review shown that due to dividing the

HV into two parts winding sensitivity of LR to the buckling of HV<sub>2</sub> winding is limited and “Yellow zone”(characteristic of marked buckling-  $5 \geq \Delta x \leq 10$  mm) corresponds to relative change of LR 2% only. The difference between LR tested on different phases also pointed to defective condition of phase **A**. It was advised removing the transformer from operation. After disassembling the active part two waves of deformation was revealed on the HV<sub>2</sub> winding phase A. Trace of overflashing between the coils was found along the supported lath due to distortion of insulation space.
