# **Transformer is gassing-What to do**

V.V. Sokolov

Z. Berler,

## **Abstract**

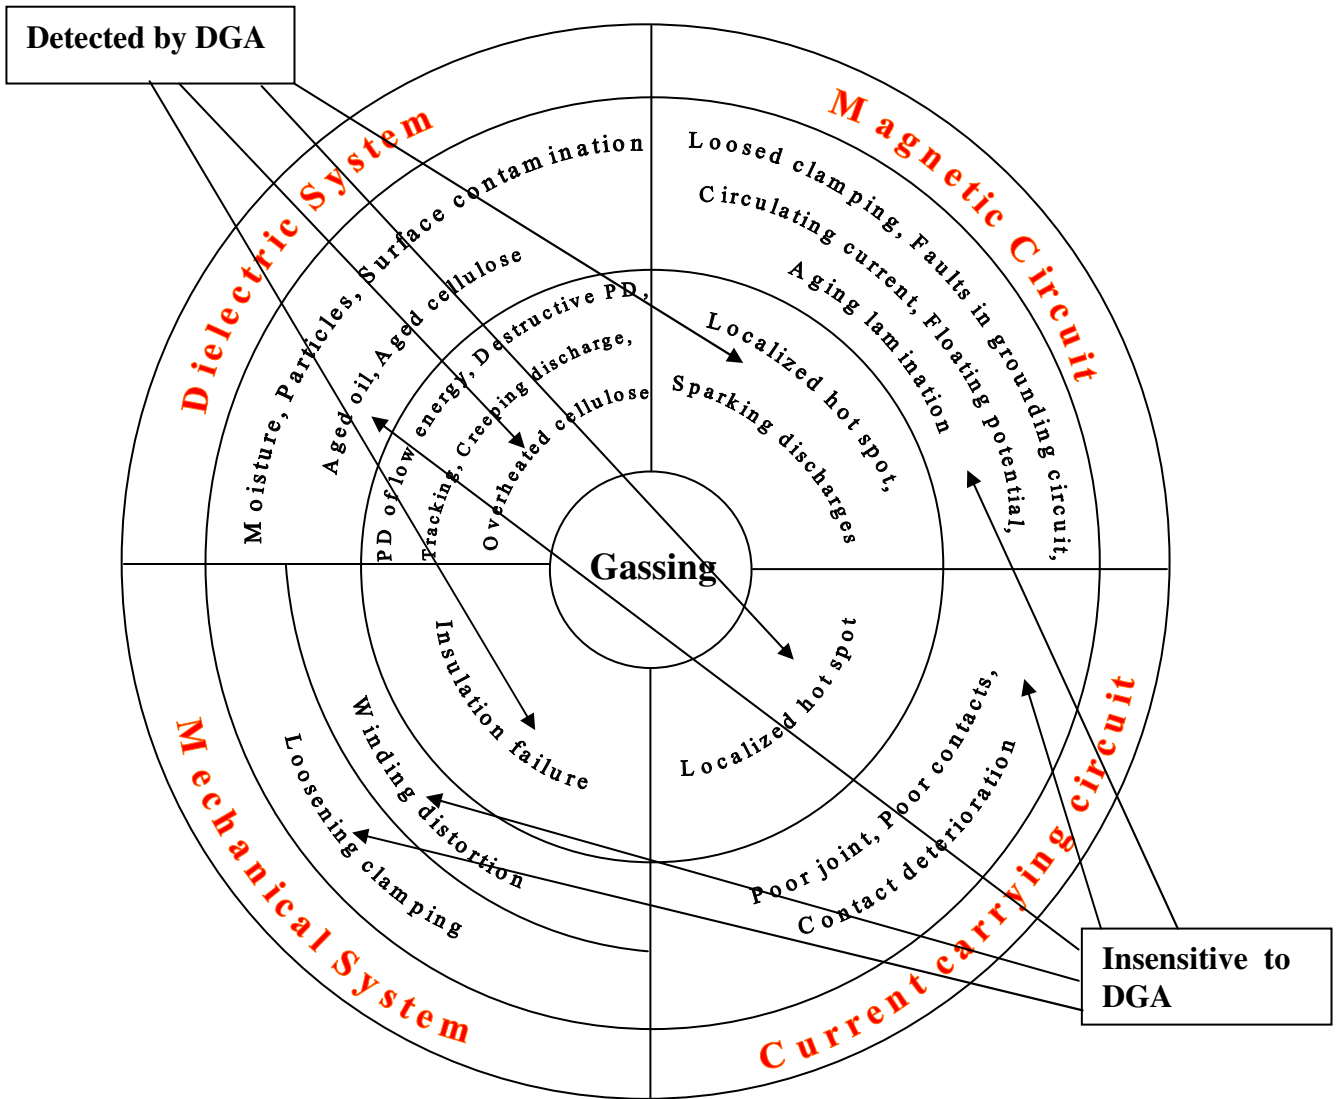
Figure 1  
Transformer Functional Failure Model.  
Possibility to detect typical defects and faults by means of DGA

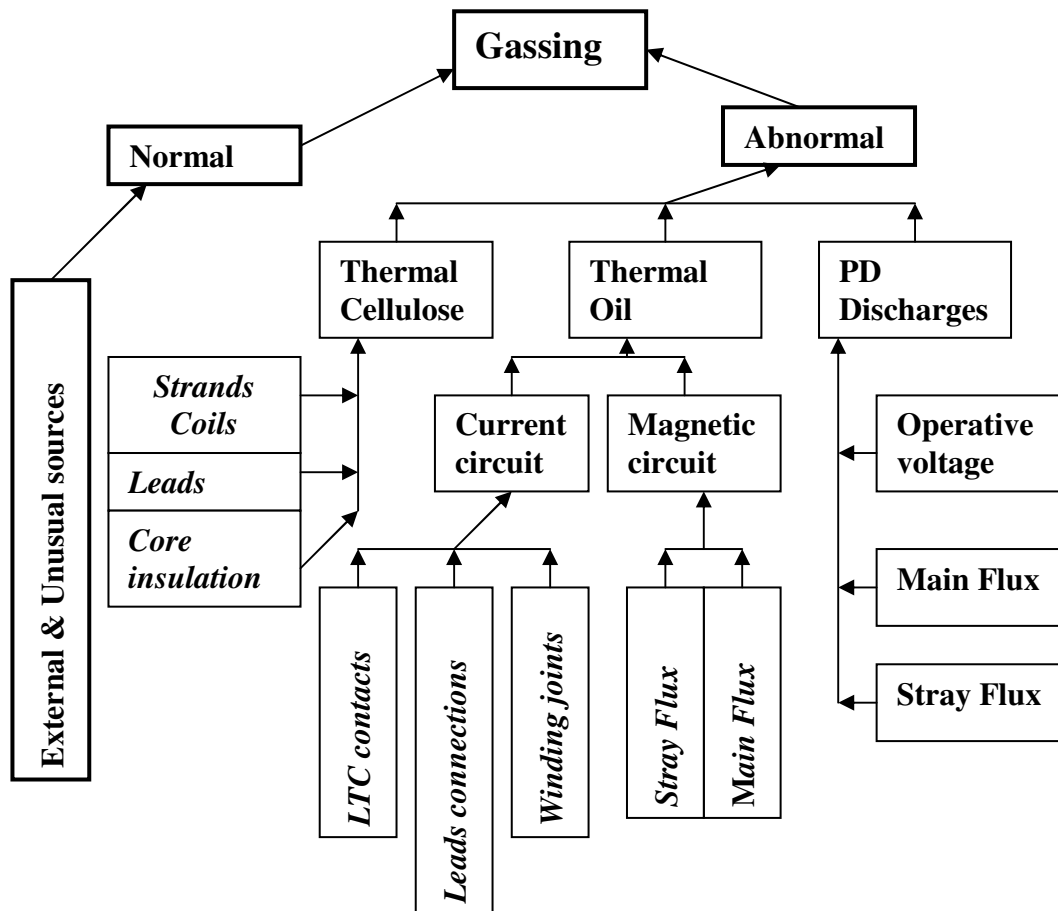
Figure 2  
Model of Gassing Transformer

To find a solution for the problem “What to do if the transformer is gassing?” it is necessary to answer the questions: are the gas concentrations normal or abnormal? Is the source of gas generation internal or external? What is the type of fault? Does the problem associated with thermal or electric faults, with operative voltage or magnetic flux, with main flux or with stray flux? What may happen if the load/voltage will be increased? The diagnostic model of gassing power transformer in Figure 2 may help to answer these questions in some instances.

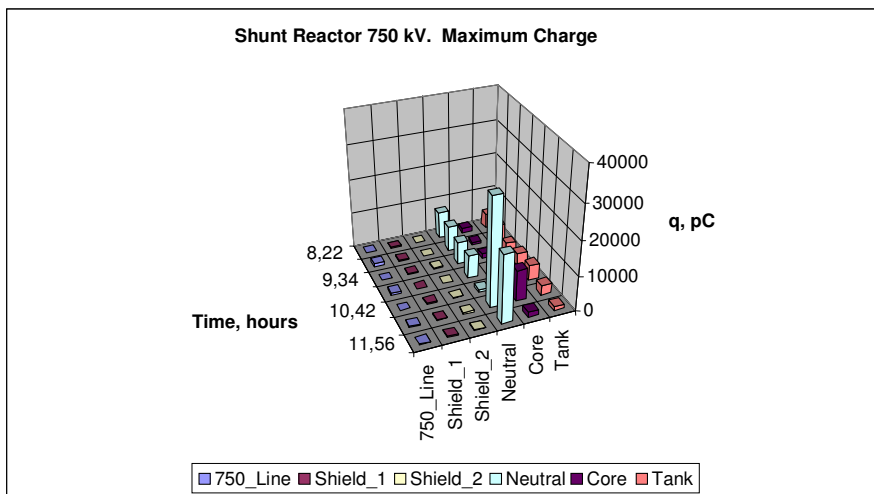
The Shunt Reactor 110 MVAR,  $750/\sqrt{3}$  exhibited both symptoms of arcing and localized overheating with estimated temperature about 800 °C. Continuing of its operation was critical, and decision was taken to verify whether the winding insulation involved. PD electrical test was performed using PD Analyzer and 6 sensors connected to the Bushing's Tap, electrostatic shields and grounding leads (see Figure 6).

Figure 7  
Distribution of PD Signals
